Prüfgerät

Fogra-Acetontestgerät ACET

Test Devices

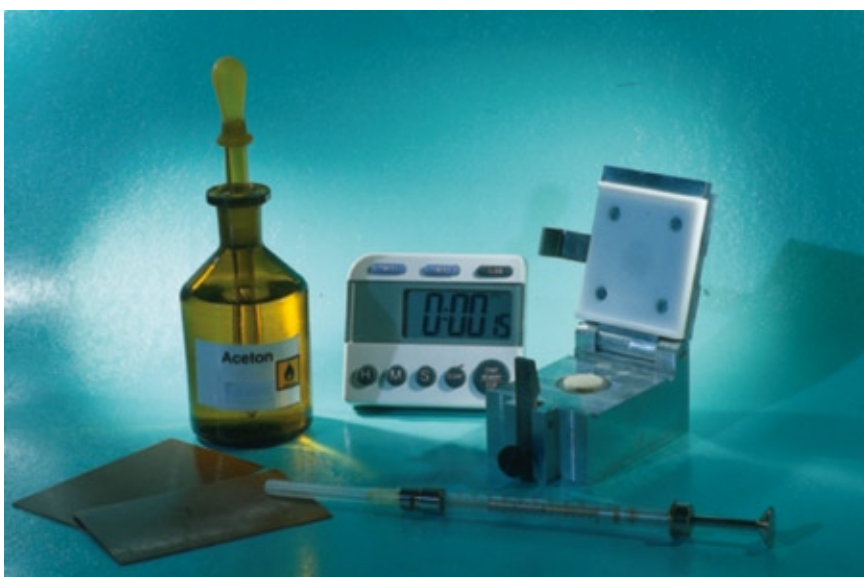
Das Fogra-Acetontestgerät ACET zeichnet sich durch seine einfache Handhabbarkeit aus und liefert reproduzierbare sowie vergleichbare Ergebnisse:

- Mit einer Spritze wird ein Lösemittel auf das definierte Filzpad genau dosiert.
- Der Anpressdruck des getränkten Pads wird nach dem Einlegen der Probe und anschließendem Schließen der Klappe durch Federkraft konstant gehalten.
- Nach dem Schließen wird die Einwirkzeit des Lösemittels mit einer Stoppuhr genau eingehalten und die Probe danach zur visuellen Beurteilung einfach aus dem Gerät herausgezogen.

dig polymerisierte Bestandteile aus der Lackschicht herauszulösen. Die Ergebnisse aus diesem manuellen Test sind allerdings stark vom Operator abhängig, da die Acetonmenge, der Anpressdruck und die Wischzeit subjektiv ausgewählt werden. Aus diesem Grund hat die Fogra ein Gerät entwickelt, um diesen Test unter definierten Bedingungen durchführen zu können.

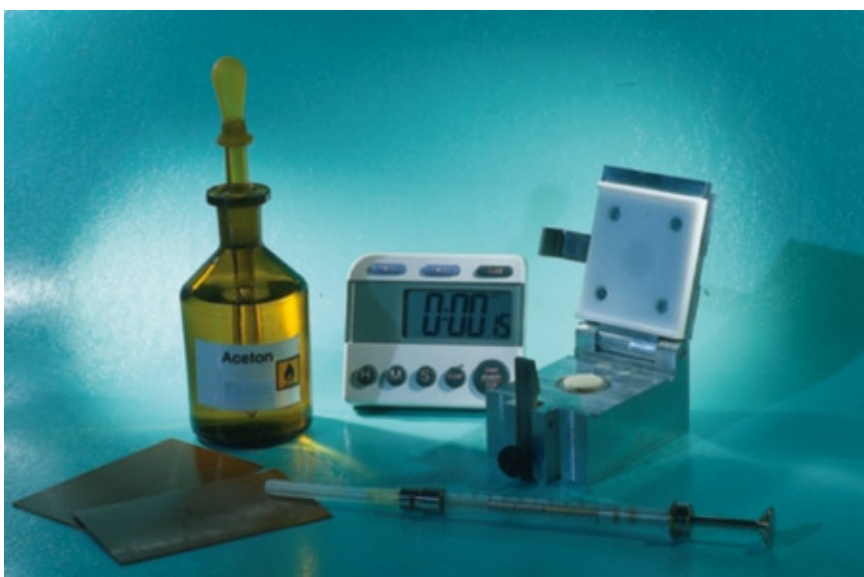
The Fogra test device for determining the resistance of UV curable layers to acetone ACET offers easy handling and yields reproducible and comparable results:

- An amount of acetone is portioned with a pipette and a felt pad soaked with it.
- The pressure that the felt pad applies onto the sample is held constant by a spring after the lid has been closed.
- After closing of the lid the contact time of acetone and sample is measured and the sample pulled out of the device after a given time.

The results of this manual test, however, are very much influenced by the person carrying out the test. Because of this, Fogra developed a test device that enables the user to perform this test under defined conditions.
